# **Ecological Conditions Update**

**January 2013**

**Terrie Bates**  
Director, Water Resources Division

**Governing Board Meeting**  
**January 10, 2013**

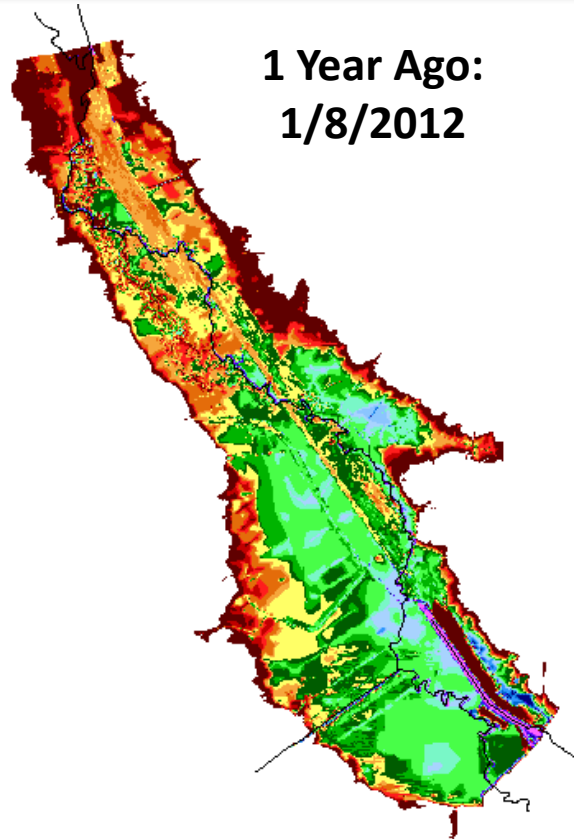
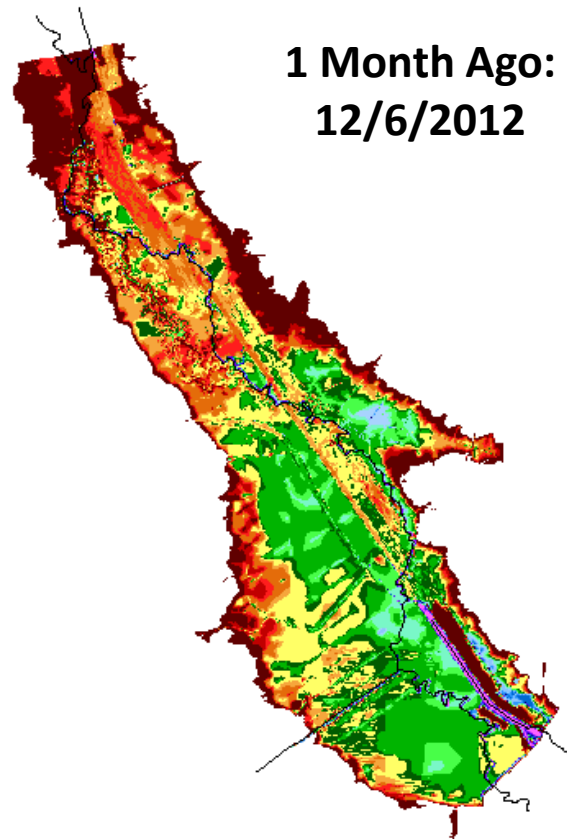
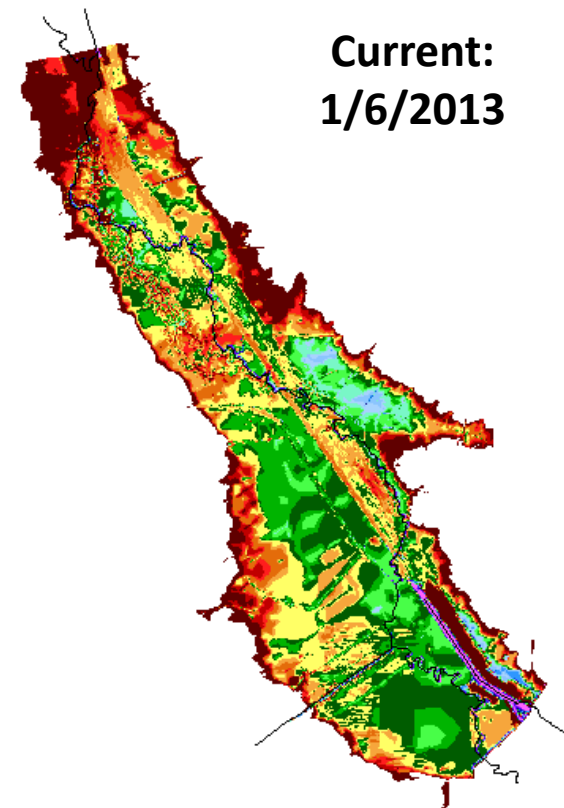
## Monthly Water Depth Maps

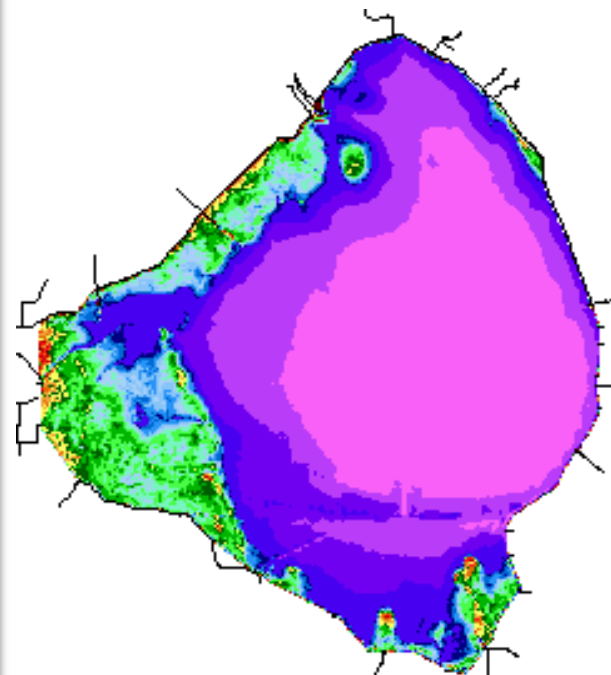
1 Year Ago: 1/8/2012

(13.53 ft NGVD29)

Lowest lake stage this year:  
11.56 ft NGVD29 (05/14/12)

Record low lake stage:  
8.82 ft NGVD29 (7/2/07)

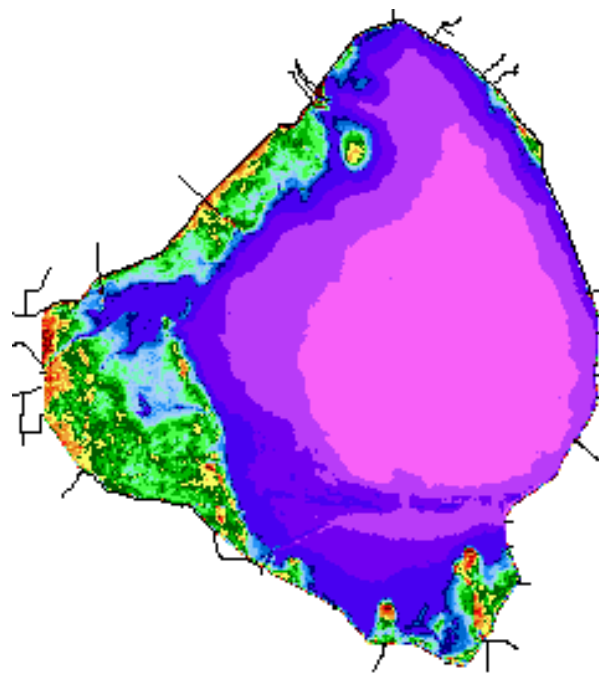
1 Month Ago: 12/8/2012

(15.03 ft NGVD29)

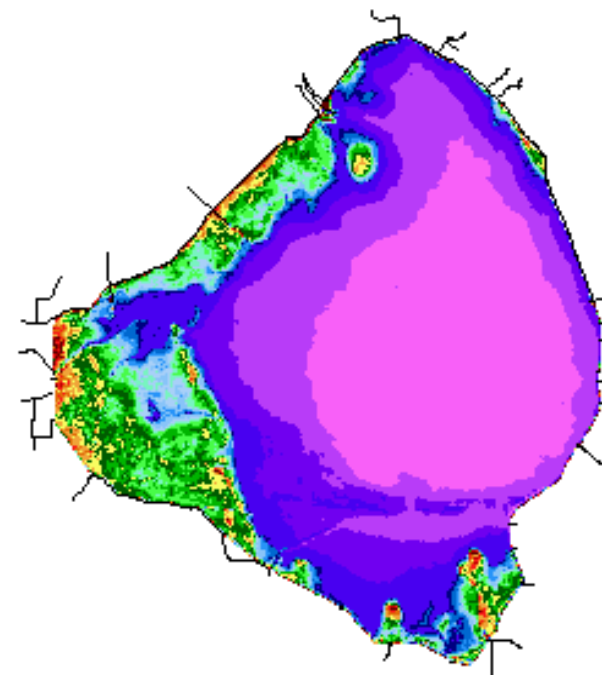
Current: 1/8/2013

(15.01 ft NGVD29)

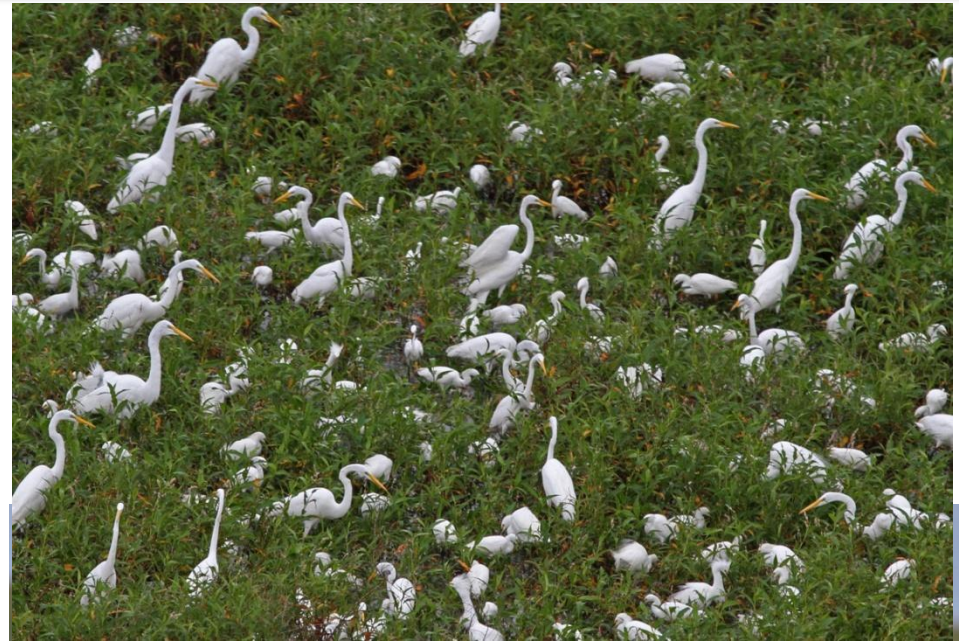
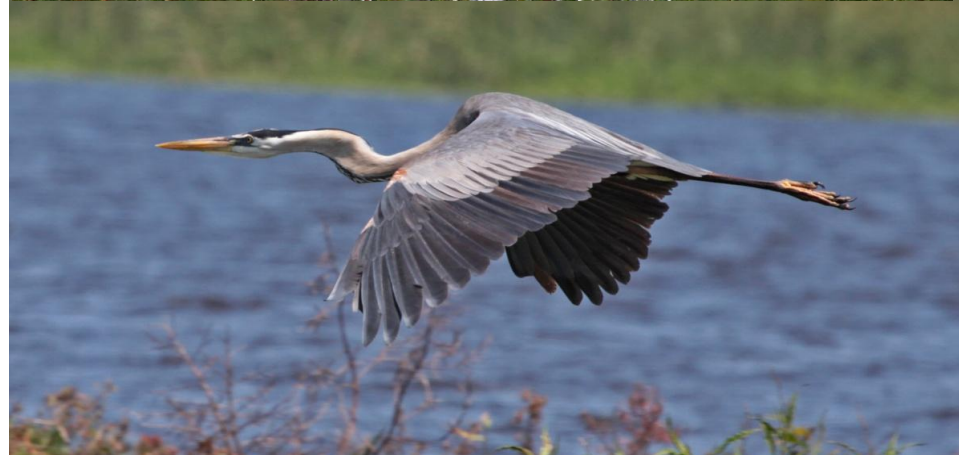
December 12, 2012

Average Stage: 15.16 NGVD  
Number of Foraging Birds\*: 3,791

- Too Wet ( $> 1.64'$ )
- Long-legged ( $0.66' - 1.64'$ )
- Short and long-legged ( $0' - 0.66'$ )
- Some Ponding
- Too Dry ( $< 0.00'$ )
- Foraging Flocks

\* Number of foraging birds is an estimation and does not account for observer bias

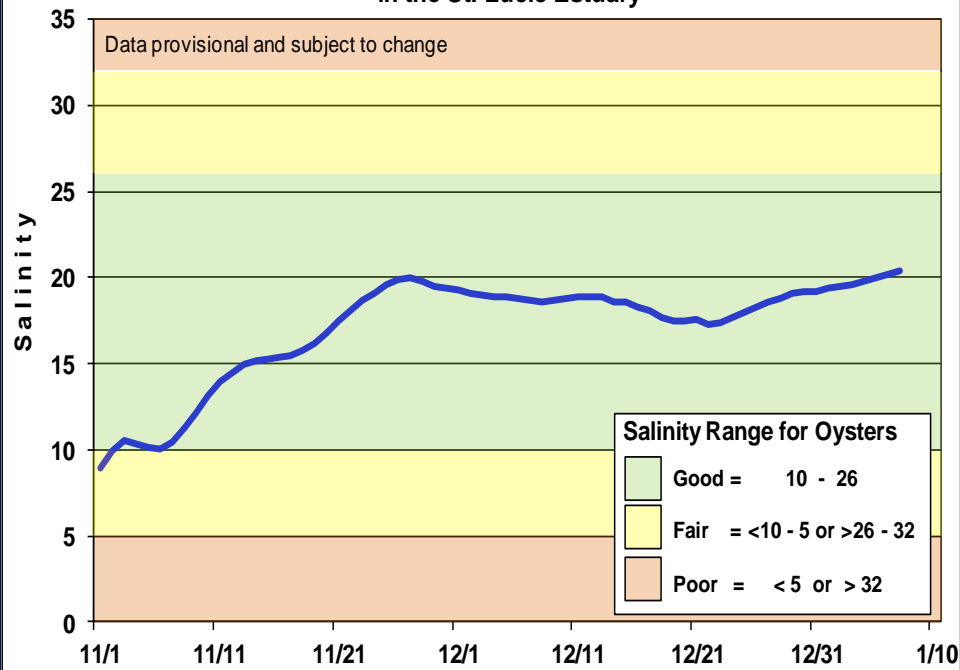
January 7, 2013

Seven day mean salinity of the water column at US1 Bridge in the St. Lucie Estuary

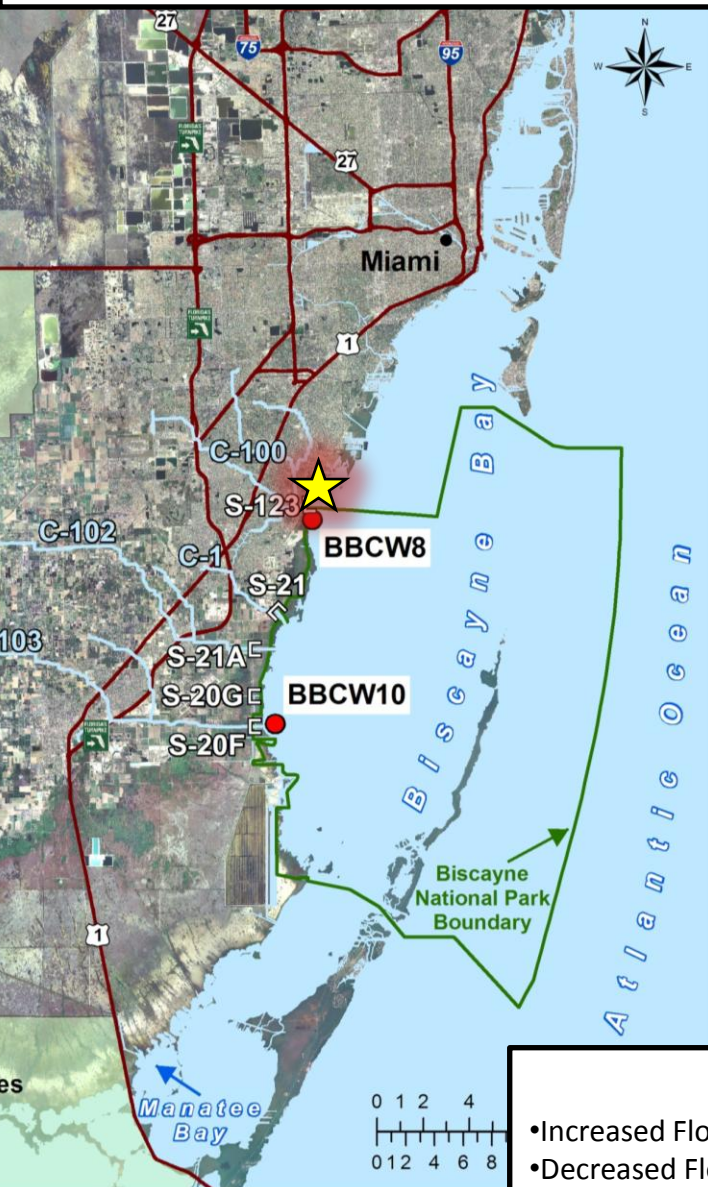
## Redirection of Flows from C-2/C-3, C-4 to Biscayne Bay December 2012

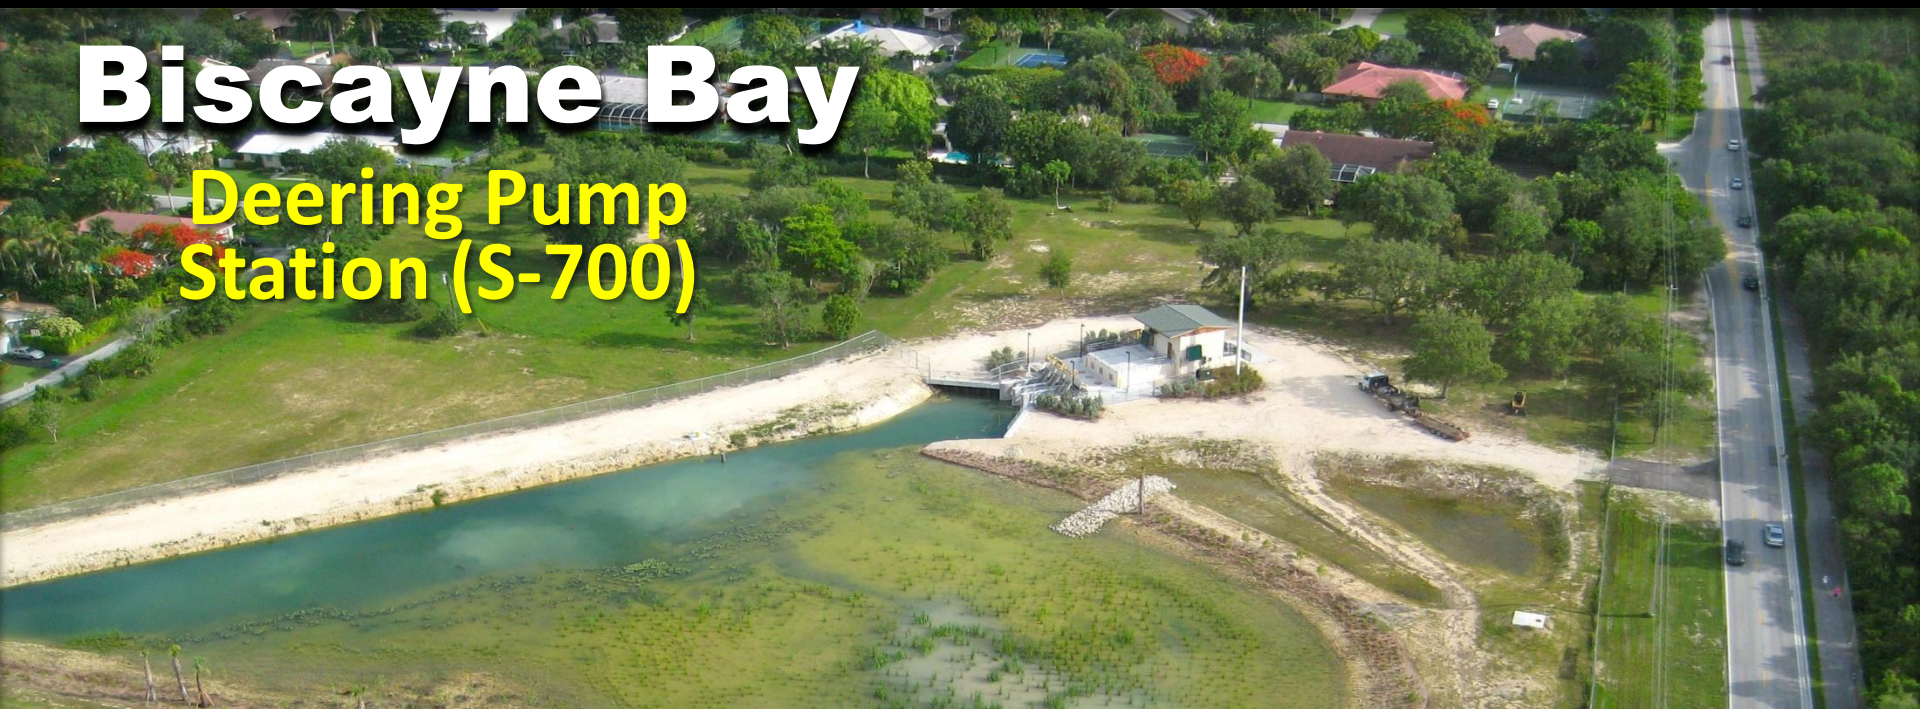
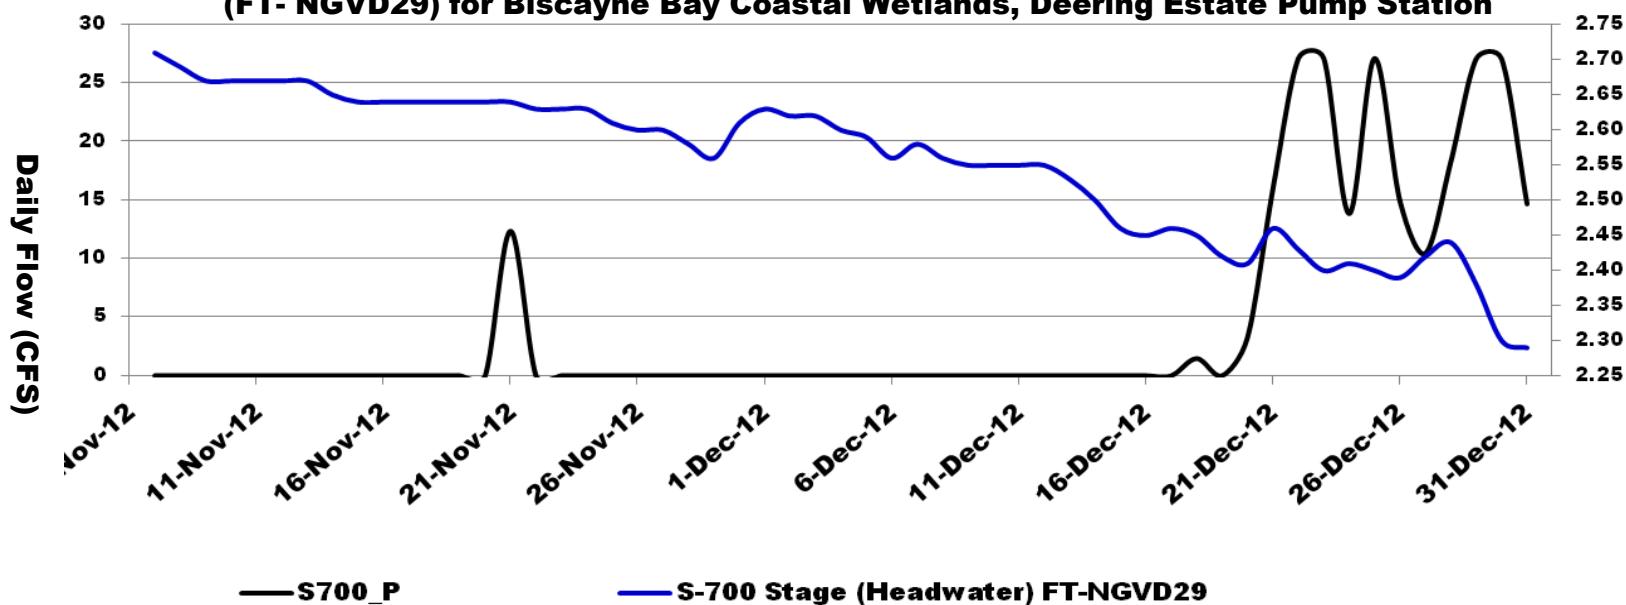
Comparison of Daily Flow (CFS) and Stage Headwater (FT- NGVD29) for Biscayne Bay Coastal Wetlands, Deering Estate Pump Station

S-700 Stage (Headwater) FT-NGVD29

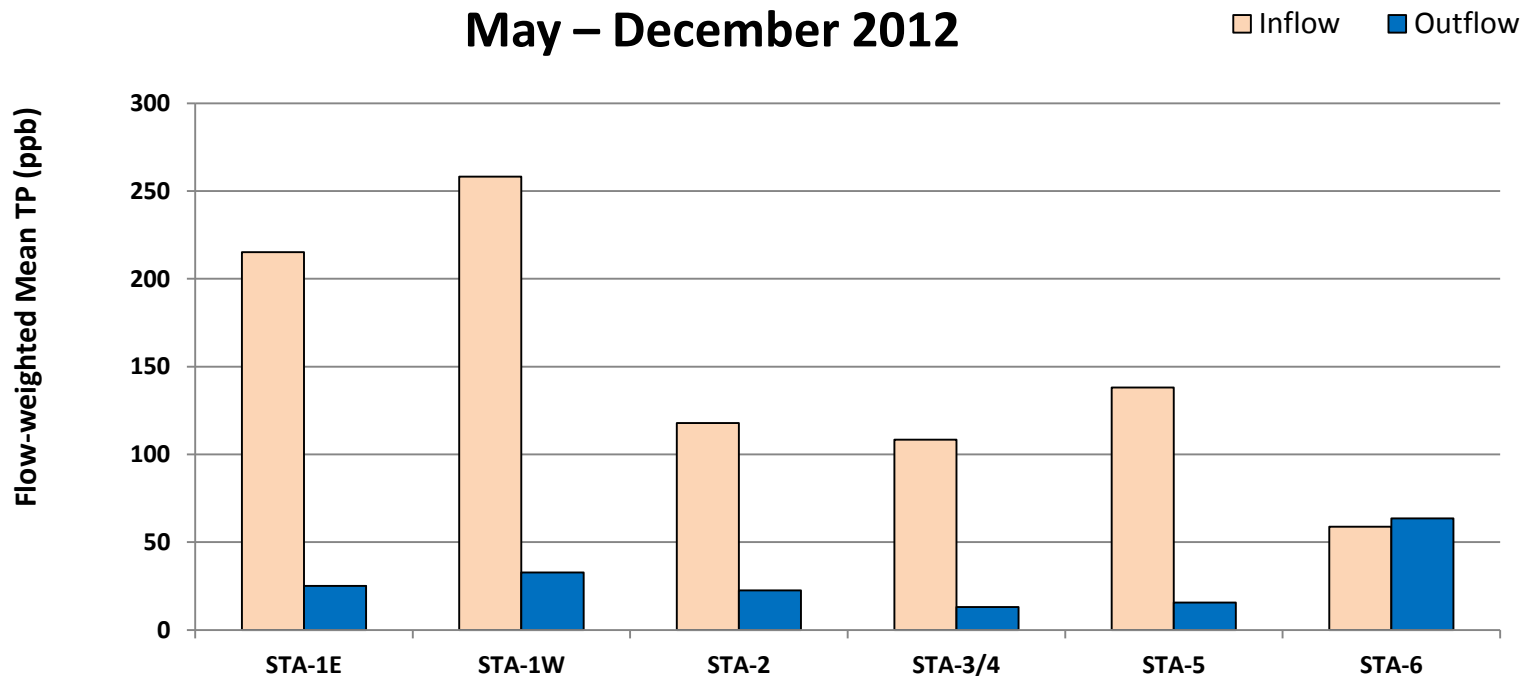
- All operational treatment cells at target
- STA-1E Cell 6 water levels lowered to encourage Submerged Aquatic vegetation growth
- Bulrush plantings continue in STA-5

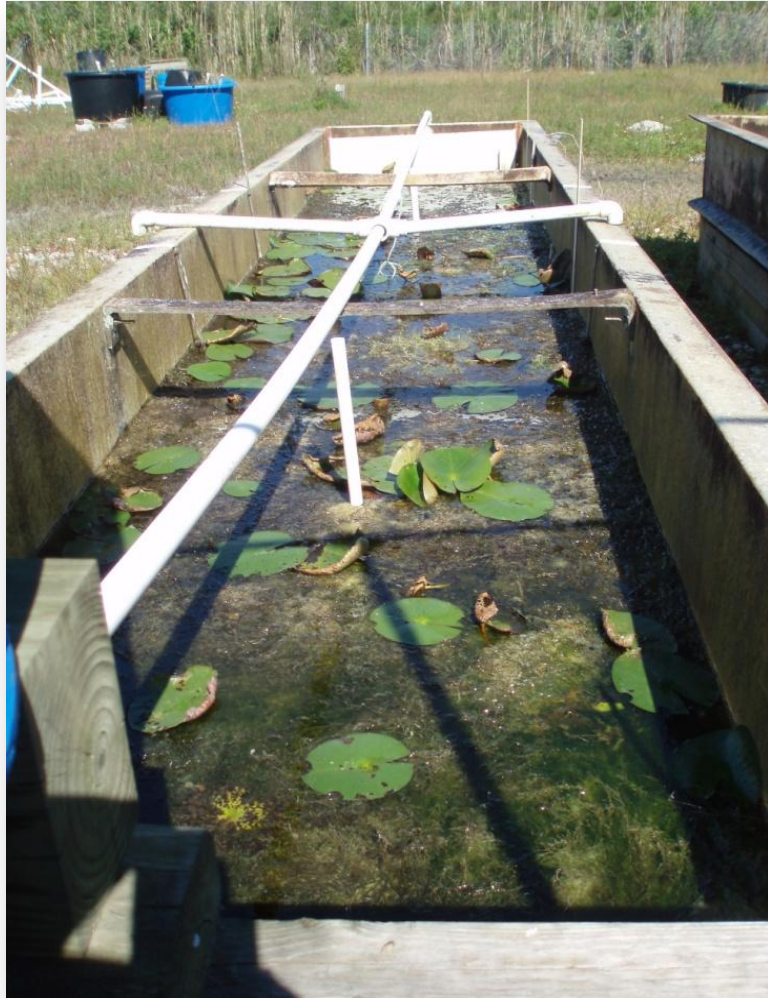
- A three year proof-of-concept mesocosm study
- Investigate Total Phosphorus removal efficacy of dominant pristine Everglades vegetation (water lily and sawgrass) under a low P condition
- Utilizes STA-1W outflow as the inflow of the study
- Outflow TP of the water lily treatment recently averaged  $11.3 \pm 1.3$  ppb with a range from 9 to 13 ppb

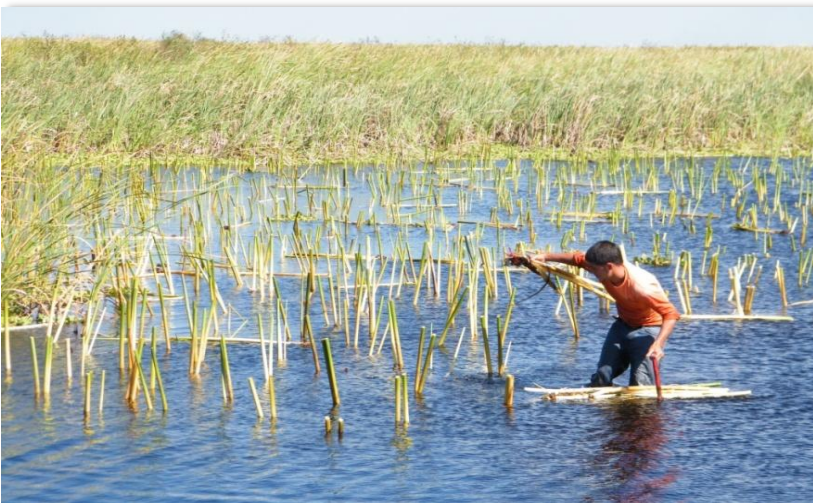
*Bulrush plantings in open water areas*

- Cell 1A Rehabilitation Activities
- Inflow canal dredging
- Reduced phosphorus and hydraulic loading
- Improved vegetation condition
- Reduced internal flux

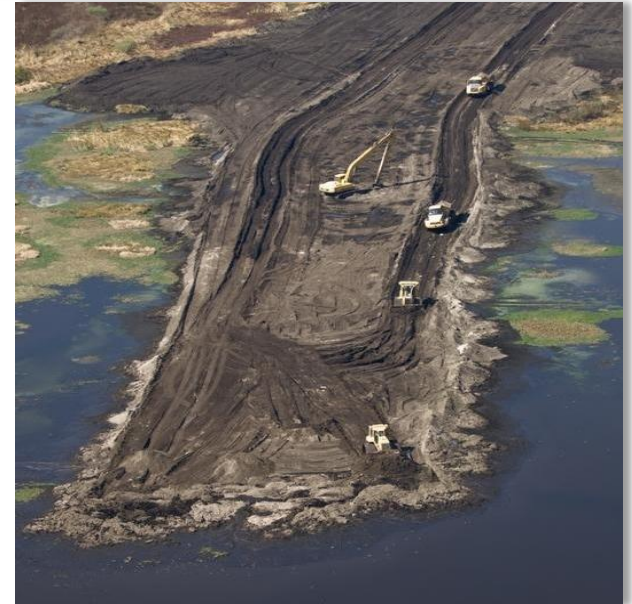
*Substantial grading to improve hydraulics*

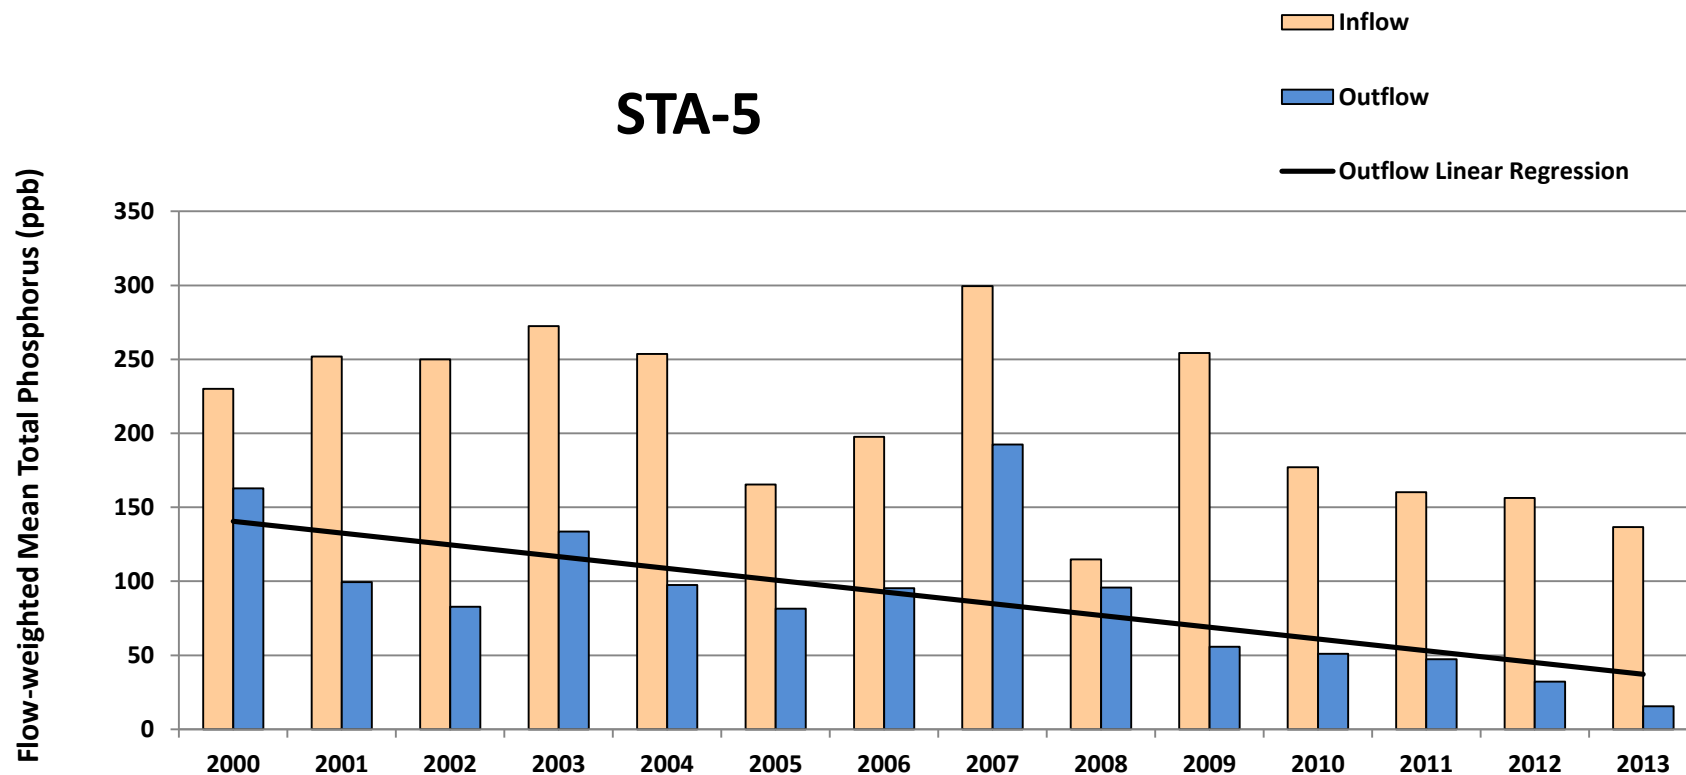
- Lowest Outflow concentration (16 ppb)

Graph contains preliminary data and partial WY13

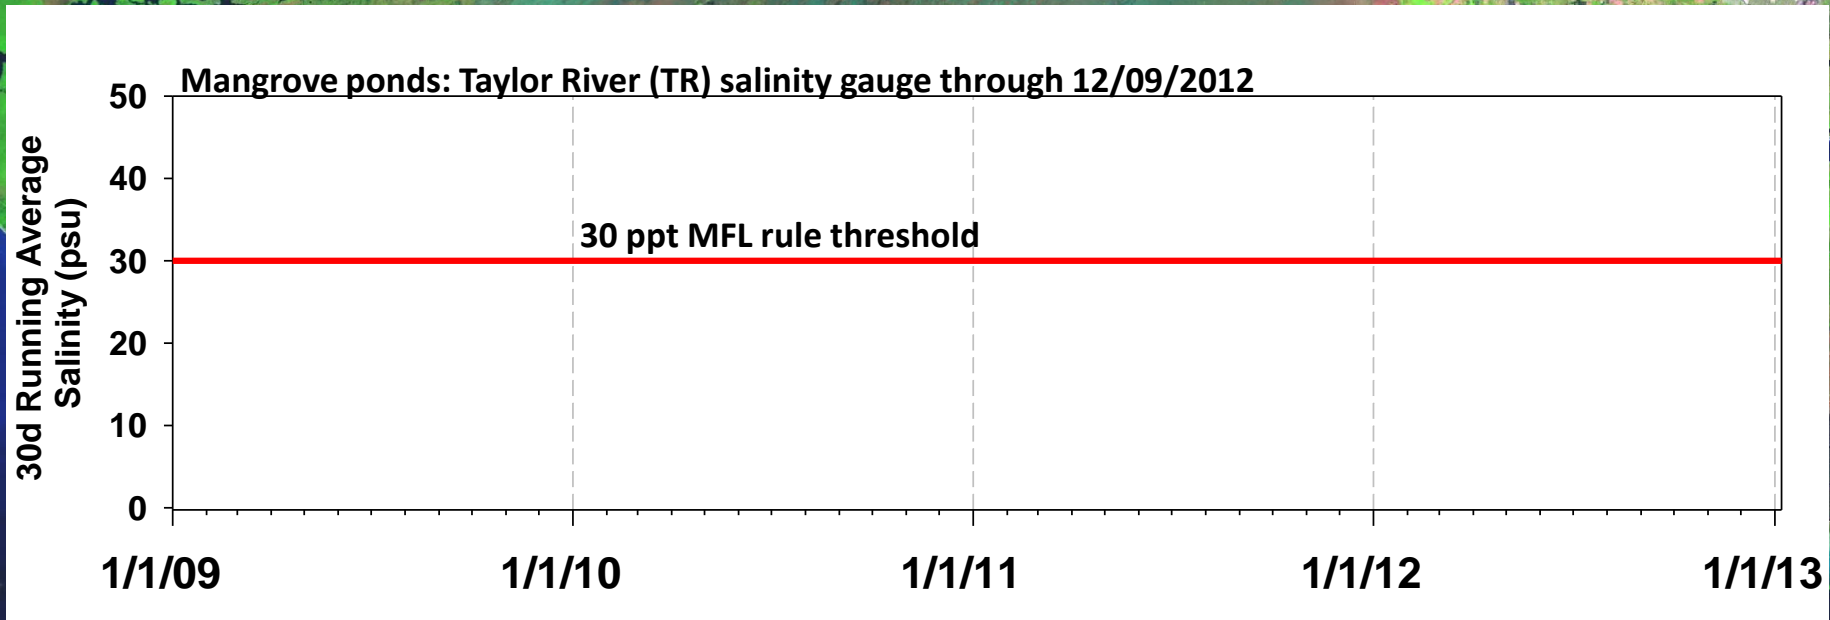
Florida Bay MFL salinity threshold was exceeded in late June of 2011

- ★ Salinity gauge
- ★ Creek flow gauge
